Subject: Structural Stability and Safety Factor Assessments

Calaveras Power Station San Antonio, Texas

Steady State Slope Stability Analysis

Ash Pond Berms - Spruce/Deely Generation Units

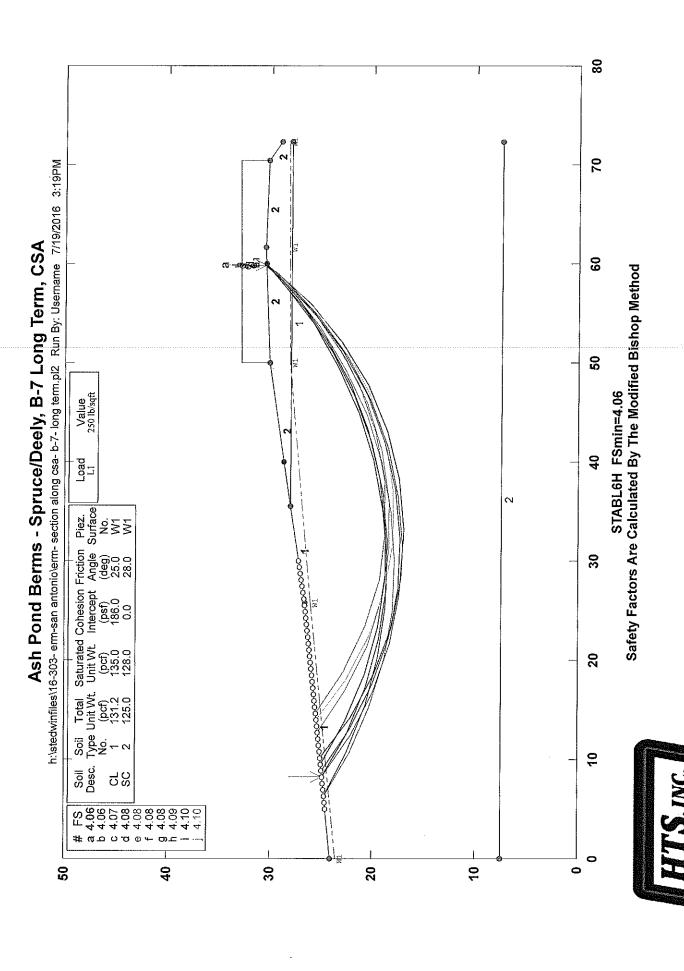
SECTION	FACTOR OF SAFETY (LONG TERM CONDITION)		
Section Along CSA	4.06		
Section Along CSB	4.08
