Project No. 0337367

Subject: CCR Units - 2017 Annual Inspection and
Fugitive Dust Control Report
Calaveras Power Station
San Antonio, Texas

Photo Log
Attachment 1

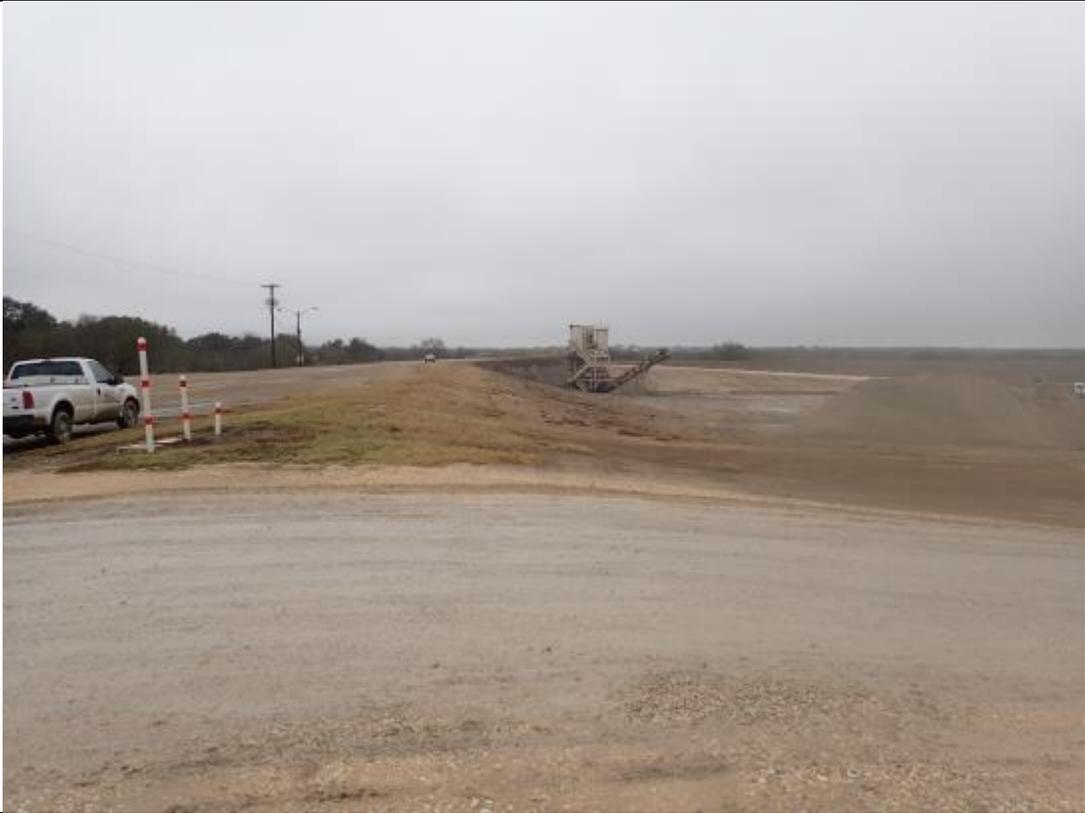
Photograph: 1 Fly Ash Landfill – standing on western berm – facing north. Mobile ash conditioning machine located in northwest corner of landfill. Photo taken 12/19/17.

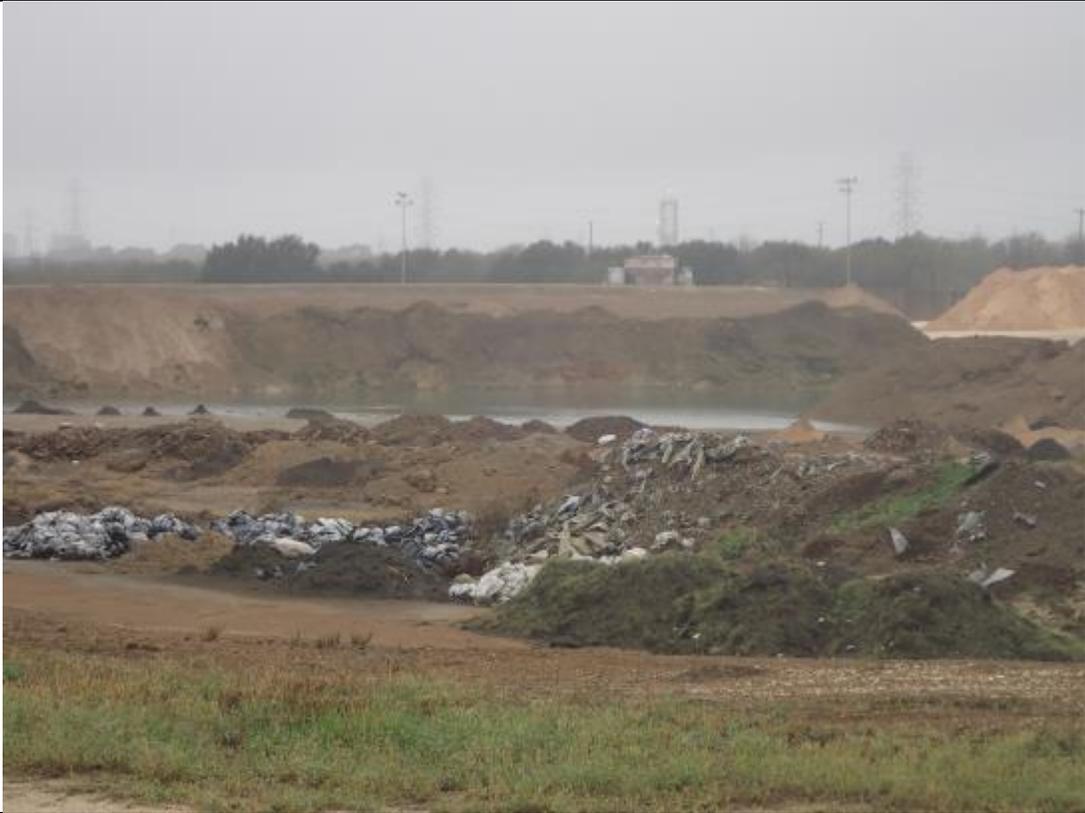
Photograph: 5 Fly Ash Landfill – standing on eastern berm – facing southwest. Water accumulation from recent rain events. Photo taken 12/19/17.

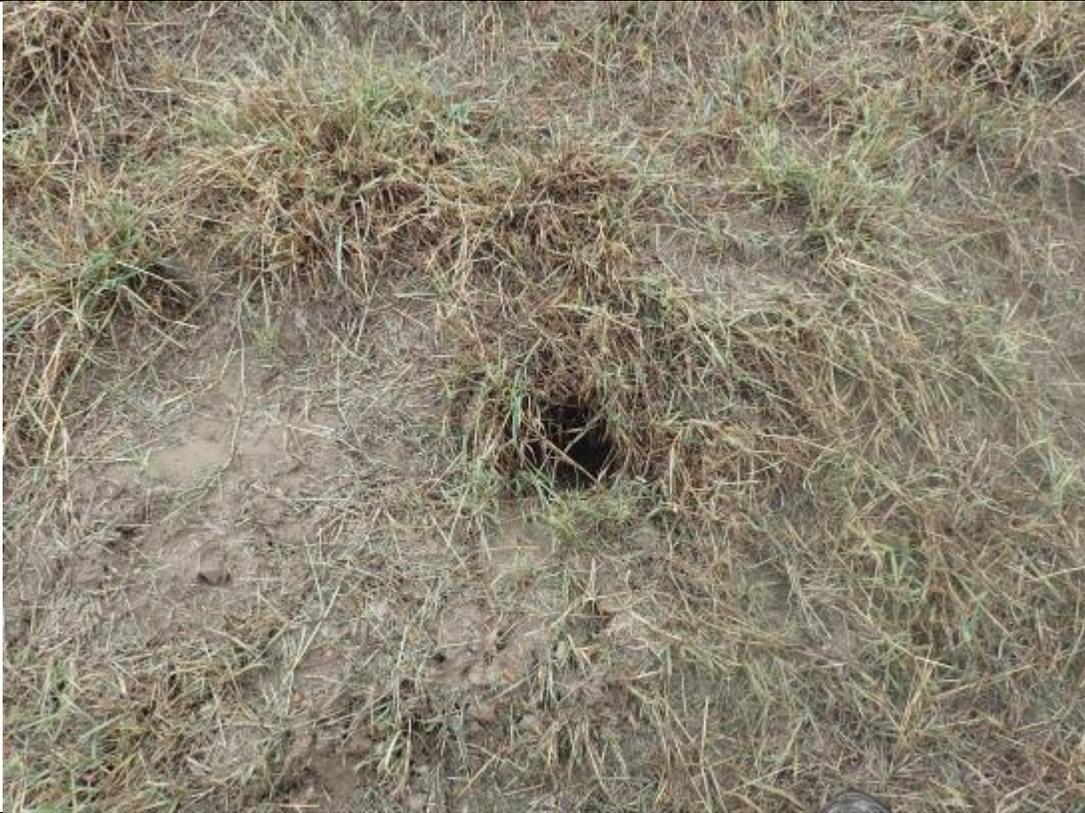
The Fly Ash Landfill (a.k.a. 5-Year Landfill) was at approximately 36.5% capacity based on calculations provided by CPS Energy. Approximately six acres of the landfill interior were covered with discrete piles of ash, the largest piles appearing to be less than 20 feet in height. Minor surface erosion was observed in the interior of the northeast corner, and minor rutting from vehicle traffic at the exterior toe of the north embankment. Two animal burrows were observed on the exterior of the north embankment, near the center of the landfill. The observed burrows were approximately two to three inches in diameter. Grass on the exterior of the landfill was less than six inches in height, with no woody plants observed. The erosion and animal burrows do not appear to immediately impact unit stability.

Photograph: 7 Fly Ash Landfill – standing on northern berm. Animal burrow in exterior slope. Photo taken 12/19/17.

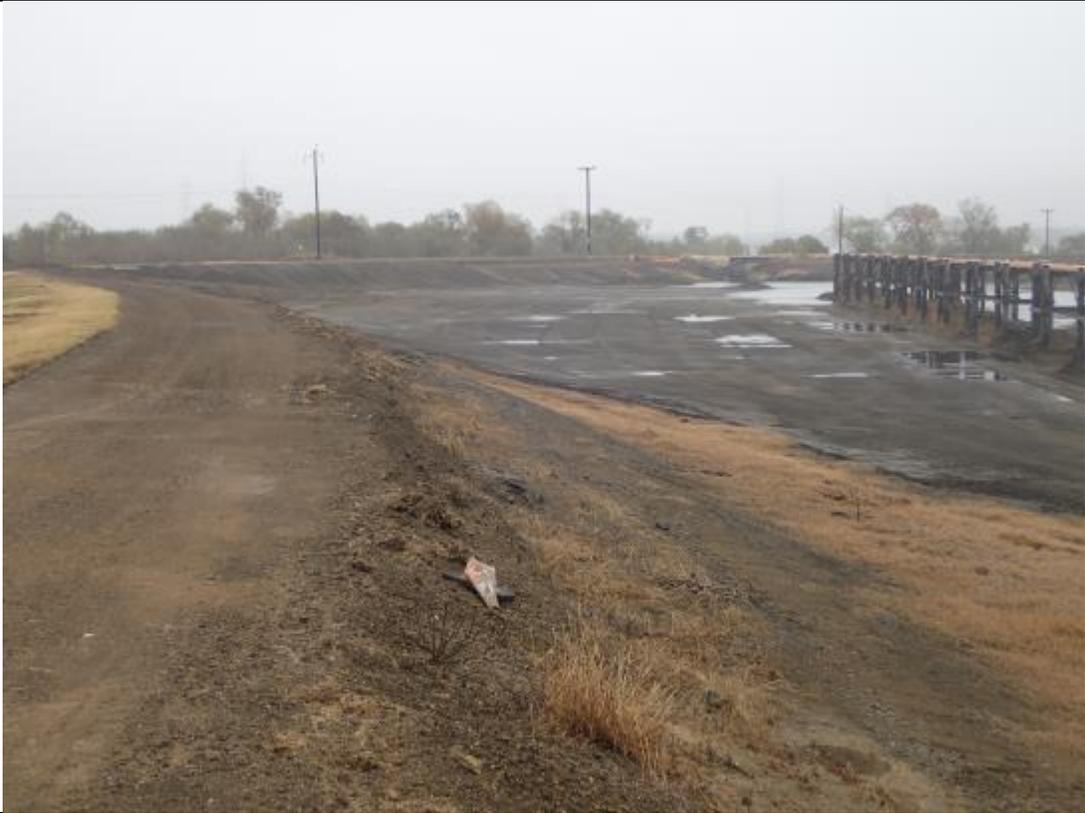
The North BAP was offline and completely drained of liquid during the inspection. Most of the accumulated CCR had been removed from the pond and transported offsite for beneficial use.

Photograph: 15 North Bottom Ash Pond – standing on southwestern corner – facing northeast. Pond was drained to remove residuals. Photo taken 12/19/17.

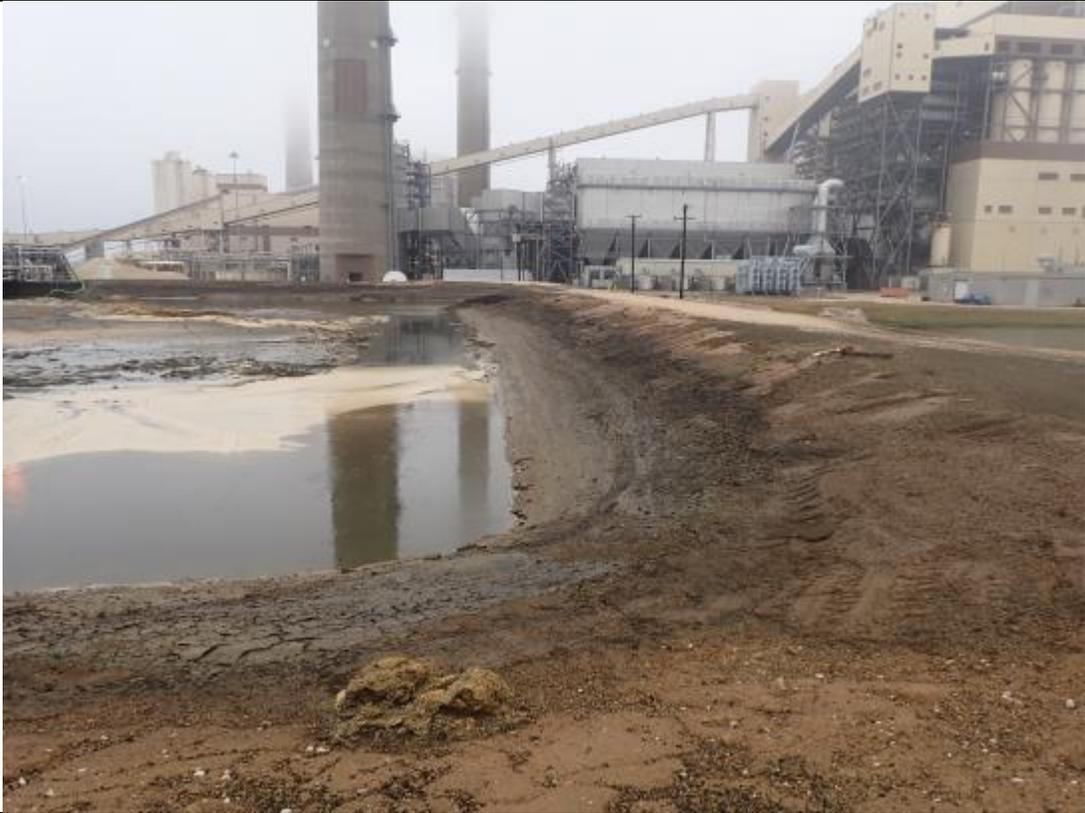
At the time of the inspection, the gate on the divider wall between the SRH Ponds was closed, with water having been drained from the North SRH Pond, and approximately six feet of water in the South SRH Pond. The North SRH Pond appeared to be approximately 75% full of CCR and had been taken offline. This corresponds to an approximate available capacity (including freeboard) of 11.0 acre-feet, with approximately 19.2 acre-feet of water and CCR contained.

Photograph: 21 North SRH Pond – standing on northeast corner – facing west. Photo taken 12/19/17.

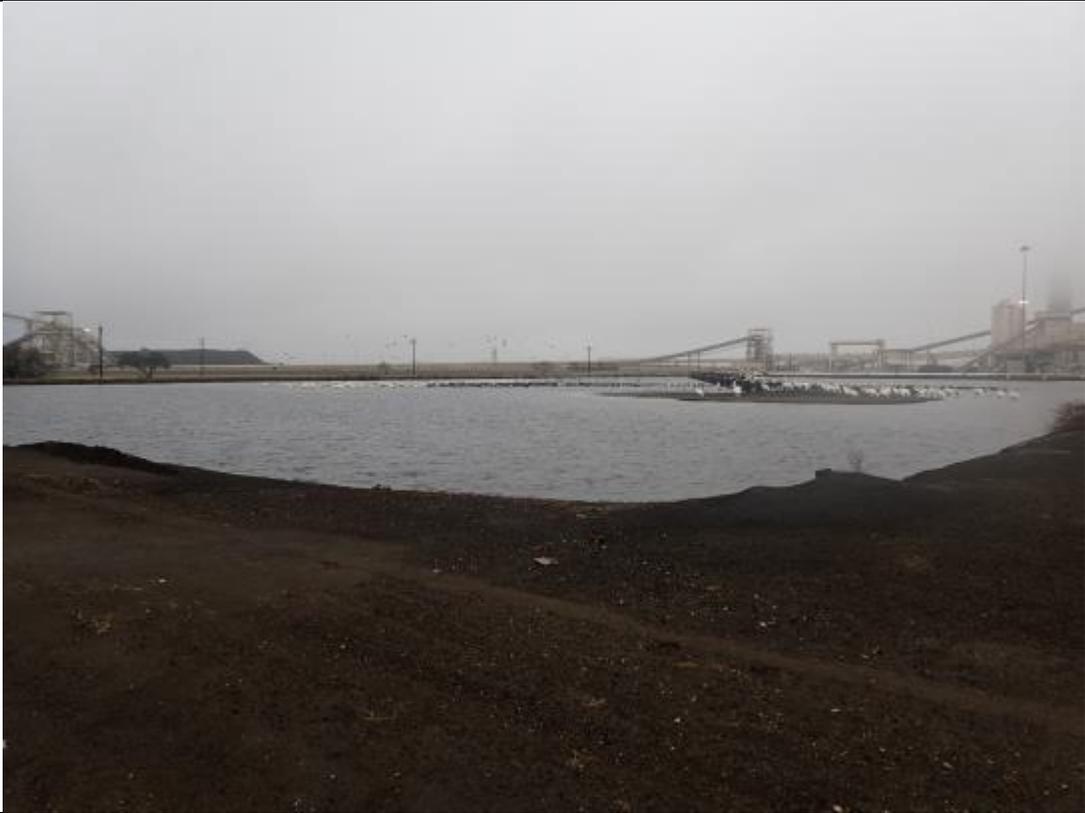
Some shallow (i.e., less than one foot deep) erosion channels were observed on interior of the north embankment of the South BAP. The eroded material appears to be mostly ash, with no evidence of damage to underlying clay. This erosion does not appear to impact unit stability. No obstruction of or damage to outfall structures were observed. High grass (i.e. one to two feet) was observed growing on the interior portion of the south berm. Grass along the external slope of the embankment was observed to be less than six inches high.

Photograph: 29 South Bottom Ash Pond – standing on northeast corner – facing southwest. Erosional features on eastern berm. Photo taken 12/19/17.
