# OUTAGE CAUSES

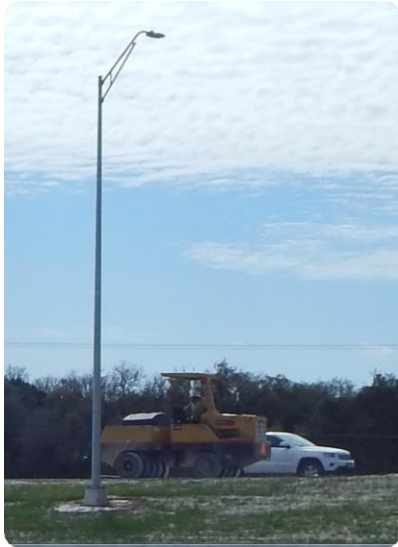
**TXDOT Light Pole Installed Where Contact With Powerlines Occurred During High Winds. IH10 & Ranchland View**

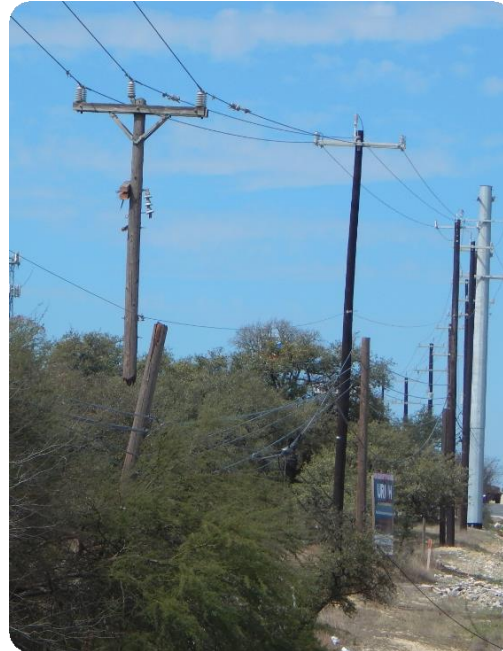
**18-Wheeler Snagged Telecom Line, Fracturing Utility Pole & Pulling Overhead Powerlines Down. IH10 Crossing @ Les Pfeiffer. Similar incident Occurred In Raintree Woods Neighborhood**

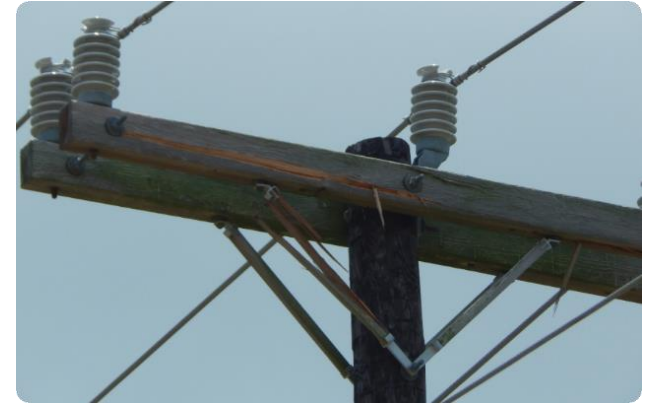
**Lightning – damaged cross arm**

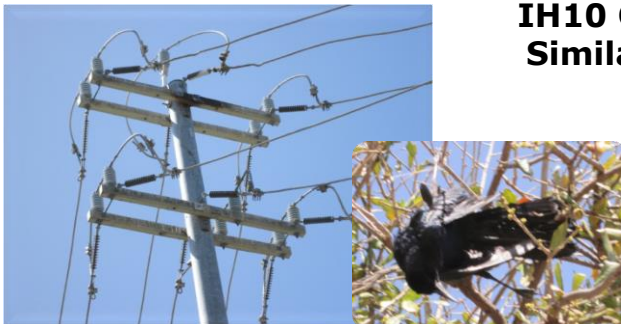
**Animals**

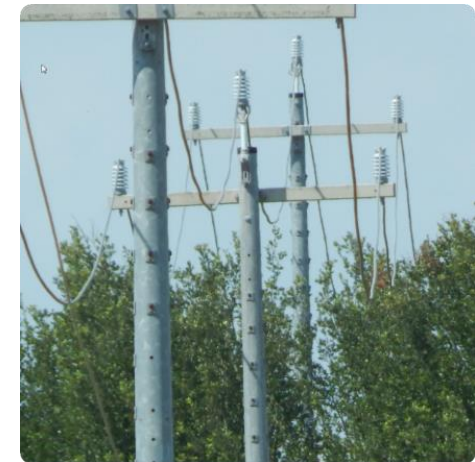
**Trees touching lines**
